## Case study Graves End

**Client:** Innovation Group

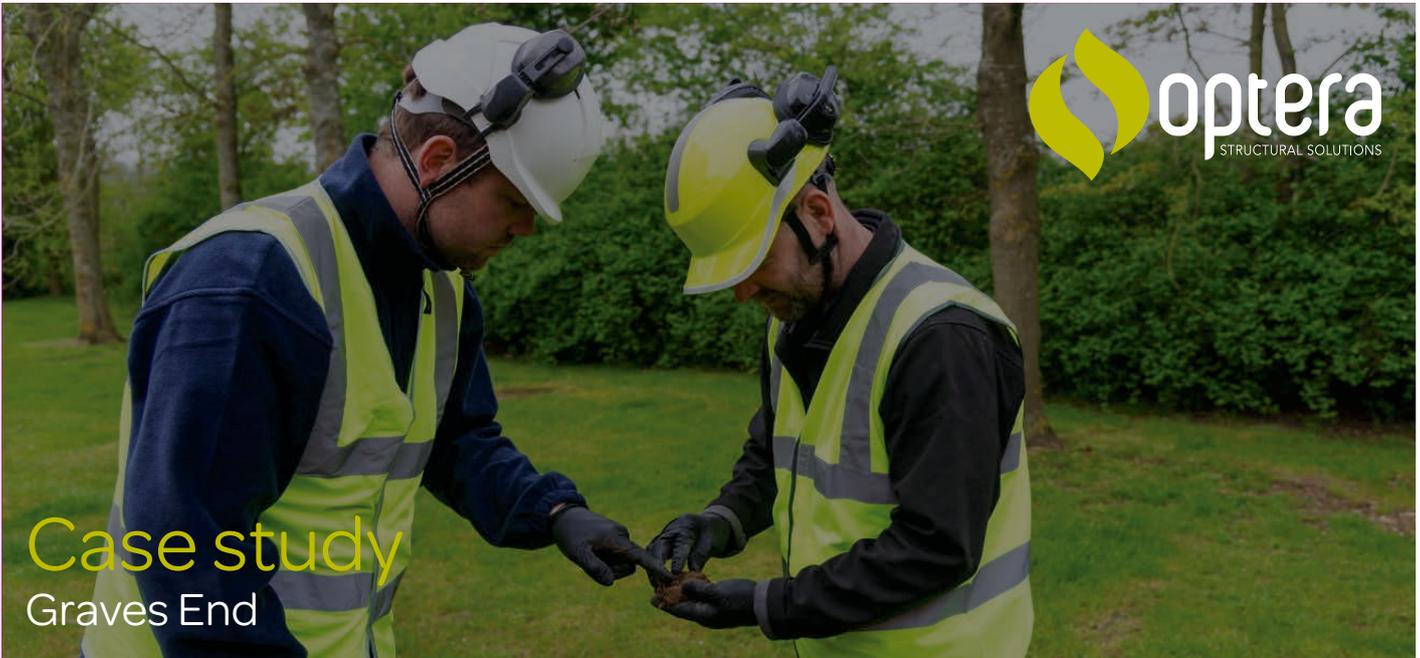
A detached garage to a property near Graves End was suffering significant seasonal foundation movement from clay shrinkage subsidence. Despite 5 years of trying, the neighbour had refused to remove their tree and the local authority confirmed it's statutory protection as the houses were within a conservation area. Insurers were faced with demolishing the garage and extension to the rear and reconstructing on a piled footing. Monitoring showed foundation movements in the order of 20mm. Cracks in the building along the left hand flank wall had been previously repaired but continued to open and at our visit, we identified that the flank elevations were not tied into the roof and the mid span buttress had been retrospectively built and was not tied to the flank wall. Consequently, we had two very slender panels of brickwork, unrestrained and subject to notable seasonal fluctuations. The floor slab was also cracked in various locations and sloped in accordance with the ground movement.

to install a 3m deep root barrier across the rear of the garage, cutting off the roots path to the foundation as well as supplying a new reinforced raft on which to reconstruct the garage.

We retained the right hand flank wall and rear extension of the structure as they had suffered relatively little cracking and tied the raft into the existing foundations thus allowing the new structure to act monolithically. Root severance was granted by the local authority and the barrier installed. The turf was lifted and protections laid across the works area. The barrier was installed to three metres. The garage was subsequently elementally demolished and the new raft installed. The project was delivered on time and budget with the insured electing to contribute towards an alternative sloping roof.
