Case study Warwick

Project: Appearing void

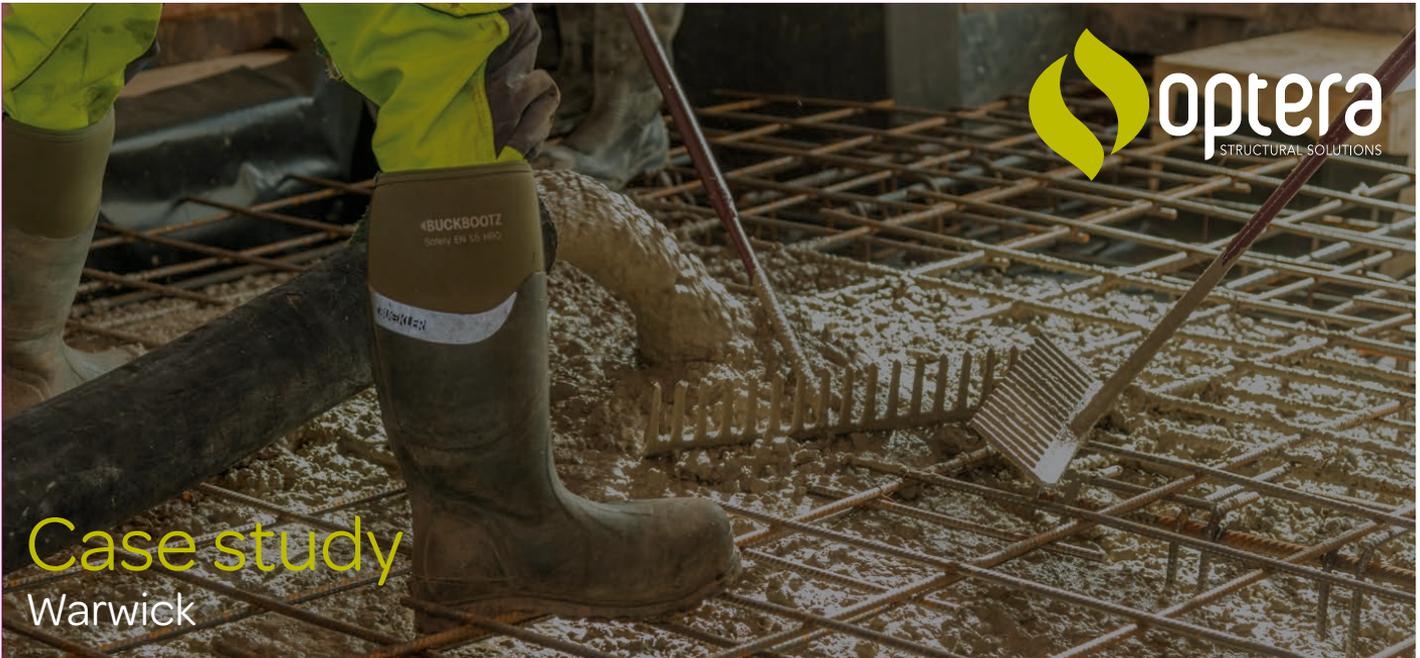
A large terraced property in the centre of Warwick reported a claim for a void appearing to the rear of the property. The house was tenanted and formed the entrance to a communal courtyard area to the rear and opened onto a busy shopping courtyard to the front. The property is next to a large restaurant and hotel meaning we had to be careful to minimise our activities on stakeholders all around the property.

The void was examined in more depth and it appears that the house which was constructed in the 1970's over the vaulted cellar of the original property. Leaking drainage and fatigue is believed to have caused the brick arch rings to fail and the void which extended the full depth of the property was full of collapsed masonry, causing the ground floor slab to be self supporting and the inner partition walls and staircase cantilevering the void. The tenants had been evacuated by the Local Authority and the landlord required the property to be habitable as soon as possible.

Surface water drainage was immediately diverted and we erected hoarding to the front and rear of the property to provide a works area and prevent unauthorised access. Our Structural Engineer designed temporary steelworks which comprised a series of beams which extended through the building to reaction points beyond the building with a series of needles which provided intermediate support, whilst we undertook sub floor works.

The ground floor was broken out and all of the rubble removed with conveyors transporting the spoil to the roadway where it was removed by skip.

Once cleared, we were able to assess that the surrounding natural ground was a competent sandstone. New foundations were cast and trench blocks used to bring the foundations up the existing ground floor. The remaining void was filled with C4 foamed concrete. We provided insulation to comply with current building regulations and reinstated the building to its original configuration. Drainage was reinstated and the rear courtyard repaired to allow the surrounding occupants to use their access and parking, was able to remain within the property for all but one day of the operation, minimising the inconvenience and disruption of long term alternative accommodation.
