## Case study

### Peterborough

**Project:** Structural lift

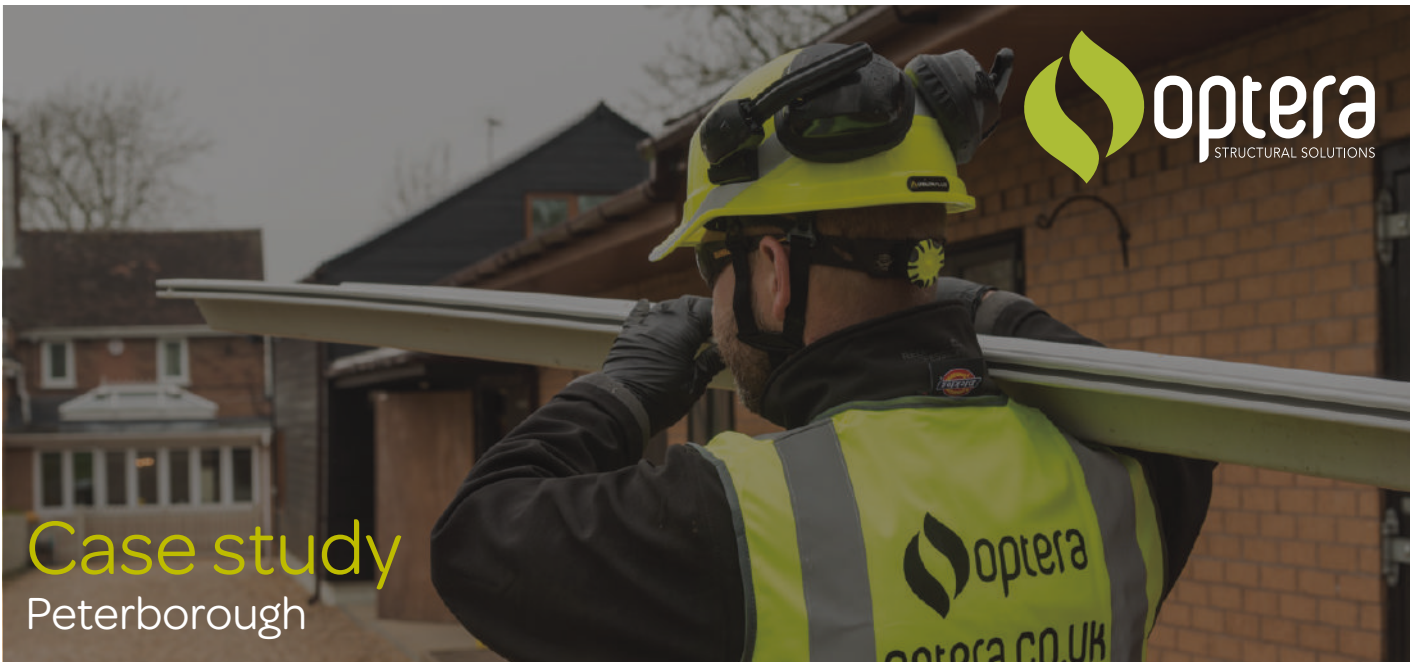
Optera were instructed by Insurers to structurally lift a chalet bungalow in Peterborough that had suffered long term progressive downward movement of the foundations over a ten year period. Despite numerous attempts at mitigation including drainage repairs and vegetation removal, the right hand side of the property continued to drop. A conservatory to the rear of the property had also rotated way from the bungalow. Ground conditions indicated a shallow band of peat over a clay soil.

We designed a scheme of bottom driven steel case piles driven across the front, right hand and rear elevations with needles under the existing footings. Using 500kN rated hydraulic lifting equipment, we jacked the right hand side of the bungalow back into level. In doing this, we effectively closed cracks on the front and rear elevations as well as rectifying the visual distortion on the front elevation to the roof line. The front lounge window was so distorted that the welds had broken and there was no lintel

above the external frame. We took the decision to deglaze the window but retain the frame during lifting. The building is now straight. Given the length of time that this claim had been ongoing, Insurers were considering demolition and rebuilding the right hand side of the bungalow at a cost of £300,000.00 with additional alternative accommodation costs on top of this.

Not every situation is suitable but Optera review existing information and can make an honest assessment of the likely success. In this case, the bungalow had been constructed on an un-reinforced raft which had split down the middle of the building. The shallow nature of the footing made lifting easier. Using laser operated monitoring equipment, we were able to lift the building without creating additional distortions and the result has been a success.
